STRUCTURAL VENTILATION OF THE BUILDING ENVELOPE

*Improve Air Quality
Reduce Energy Consumption
Minimize Moisture Contamination and Deterioration
Of the Building Envelope*

Sam S. Vacek, BSArE, MSCE, PE¹

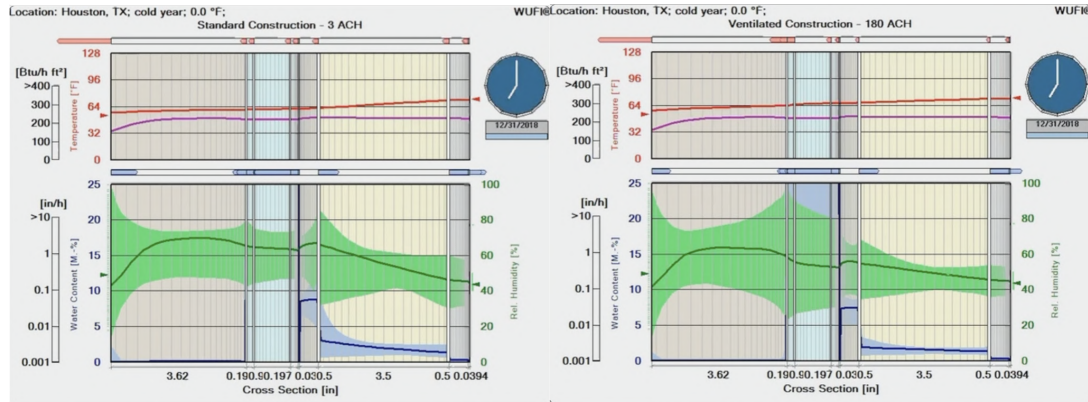
The wall assembly shown in Figure 9.1 is the conventional system and Figure 9.2 is the SV system. Brick veneer is on the left, gypsum board is on the right. Blue is air, yellow is insulation. The grey area between the air and insulation is OSB sheathing. The green shading is the relative humidity of the air and the components, red is temperature, and dark blue is moisture content.

Figure 9.1 - Conventional System at Wall

Figure 9.2 - SV System at Wall

Over a one year period, at the conventional system, exclusive of components outside the air cavity, the surface relative humidity exceeds 80%. Mold growth is expected. Nail corrosion is expected. OSB moisture contents are elevated.

At the SV system, these conditions do not exist.

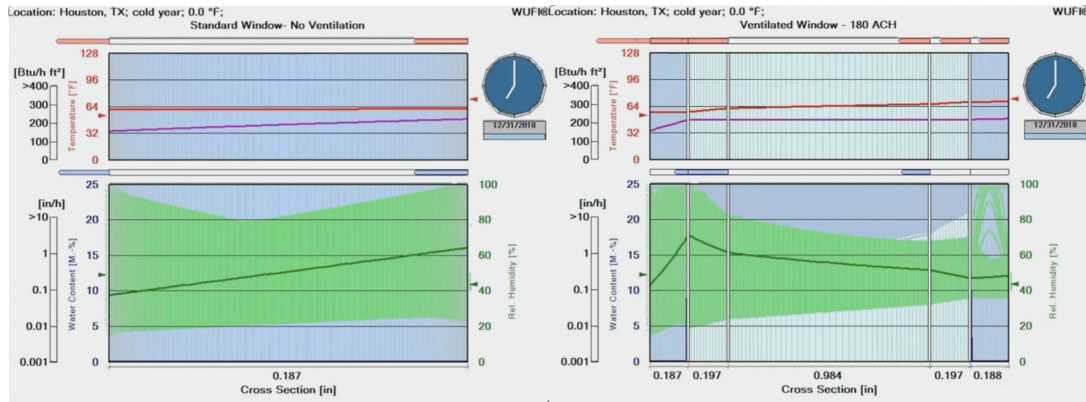
The window assembly shown in Figure 11.1 is the conventional system and Figure 11.2 is the SV system. The left figure is of a single pane of glass. The right figure is conditioned airflow sandwiched between two panes of glass. The green shading is the relative humidity of the air, red is temperature, and dark blue is moisture content. The interior glass surface humidity is lowered 50%.

Figure 11.1 - Conventional System at Window

Figure 11.2 - SV System at Window

In this instance, it would be preferable to use insulated glass at the exterior pane to minimize condensation.

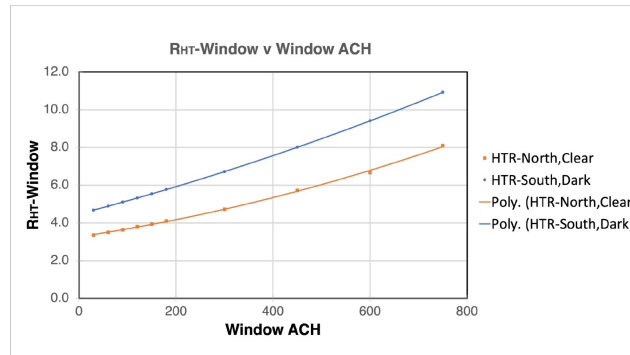
Figure 16 shows the R_{HT} of the windows of both buildings. In each, static thermal resistance of a single pane clear window is approximately $RSI_{HT}=0.2$ ($R=1$). Southern exposure and dark tint of the window results in a increase of R_{HT} by a factor of 1.5.

Figure 16 - R_{HT} of Windows

With SV, the hygrothermal resistance increases significantly with greater air flow rates. Doubling the air flow rate increases R_{HT} by a factor of 1.3. **At the Office Building, the Window ACH = 180 resulting in $RSI_{HT}=0.9$ ($R_{HT}=5$).** **At the School Building, the Window ACH = 585 resulting in $RSI_{HT}=1.4$ ($R_{HT}=8$).**

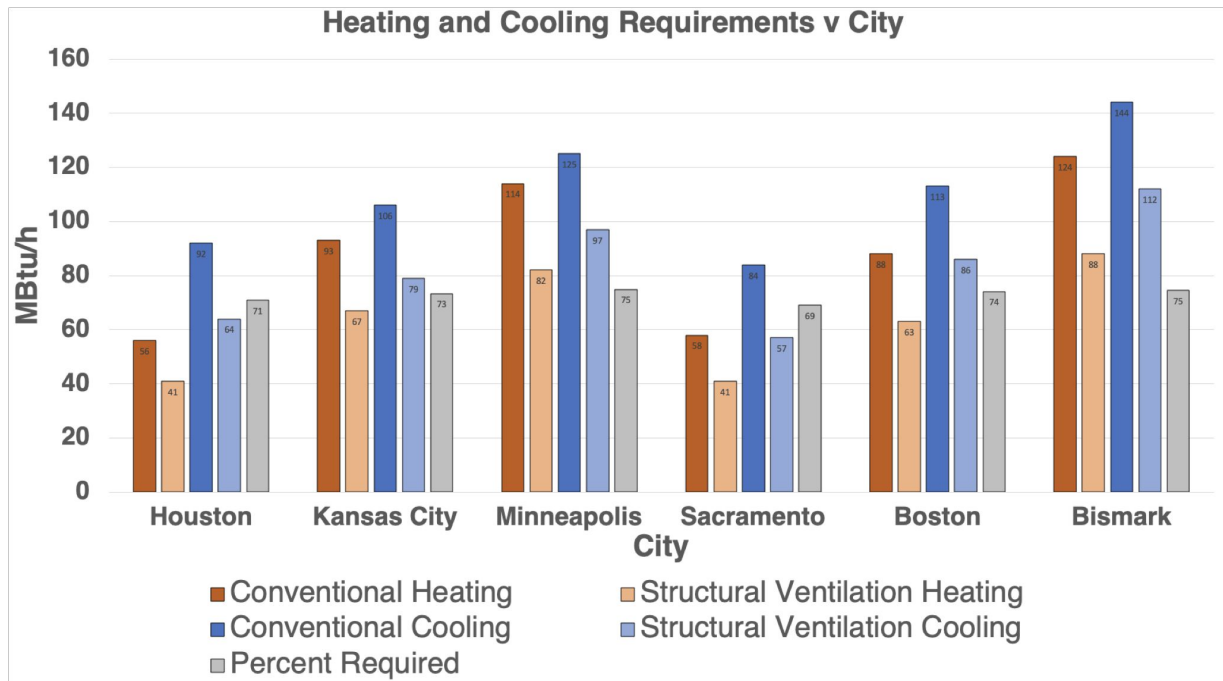
Figure 17 provides the heating and cooling requirements of the building in various cities. At each city, the conventional heating and cooling requirements are shown as the tall orange and blue bars. The SV heating and cooling requirements are shown as the short orange and blue bars. The grey bars are the percent SV unit sizing is of conventional unit sizing. **The percentages range from 69% to 75%.**

Figure 17 - Office Building Heating and Cooling Requirements v City

SV results in smaller equipment sizes regardless of location.

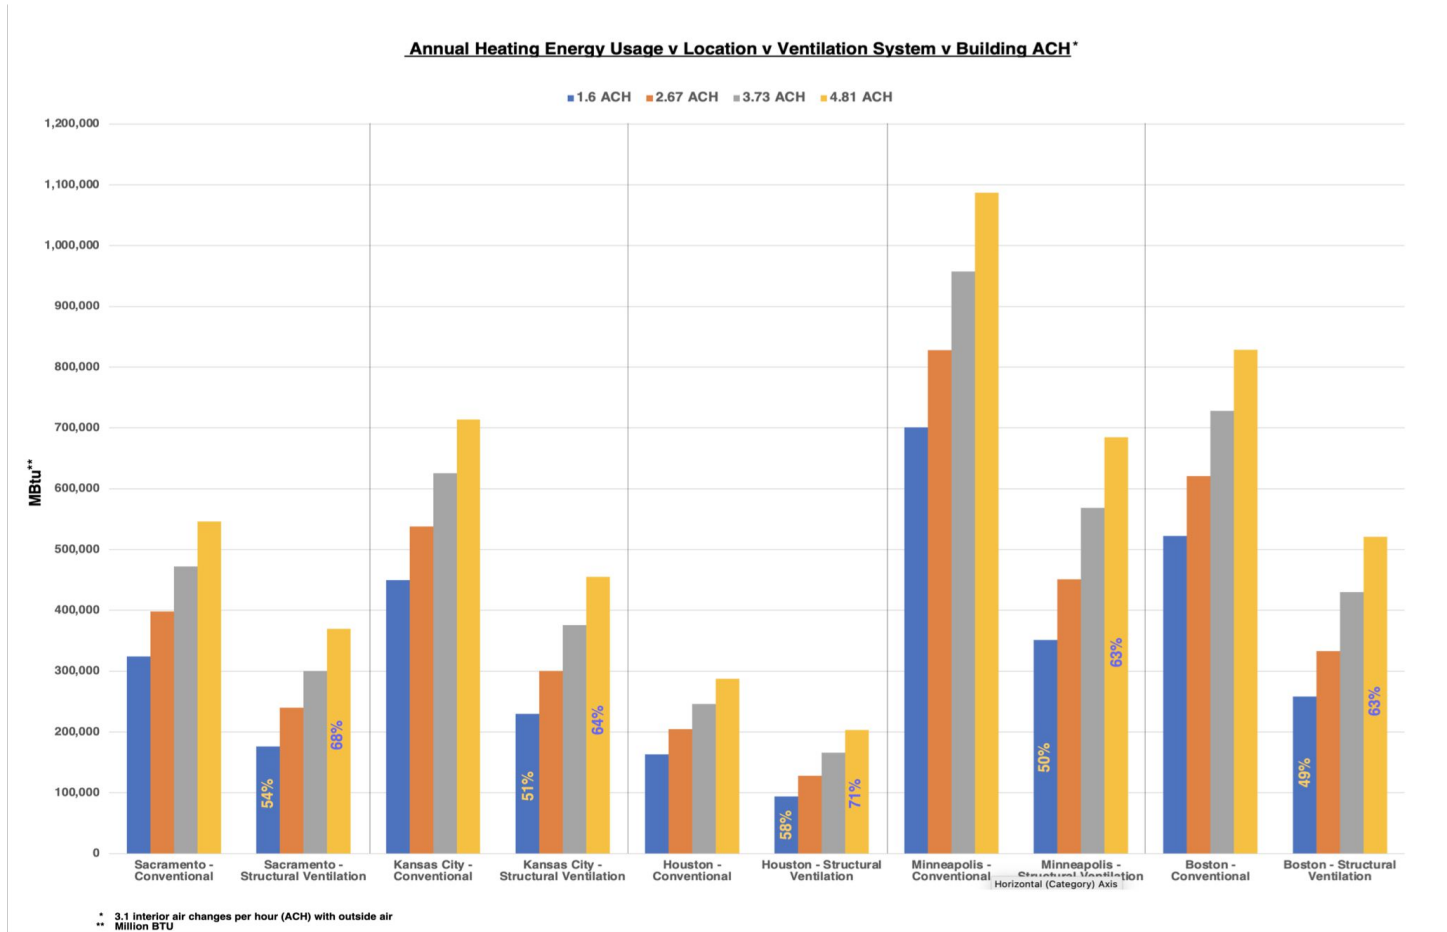
Figure 18 provides the annual heating energy usage of the building at several cities. The conventional heating and SV heating requirements are presented as separate groups. The SV group shows percentages in the bars that indicates the percent SV energy usage is of conventional usage. **The percentages range from 49% to 71%.**

Figure 18 - Office Building Heating Energy Usage v City v Ventilation System v Building ACH

SV results in significant energy savings regardless of location.

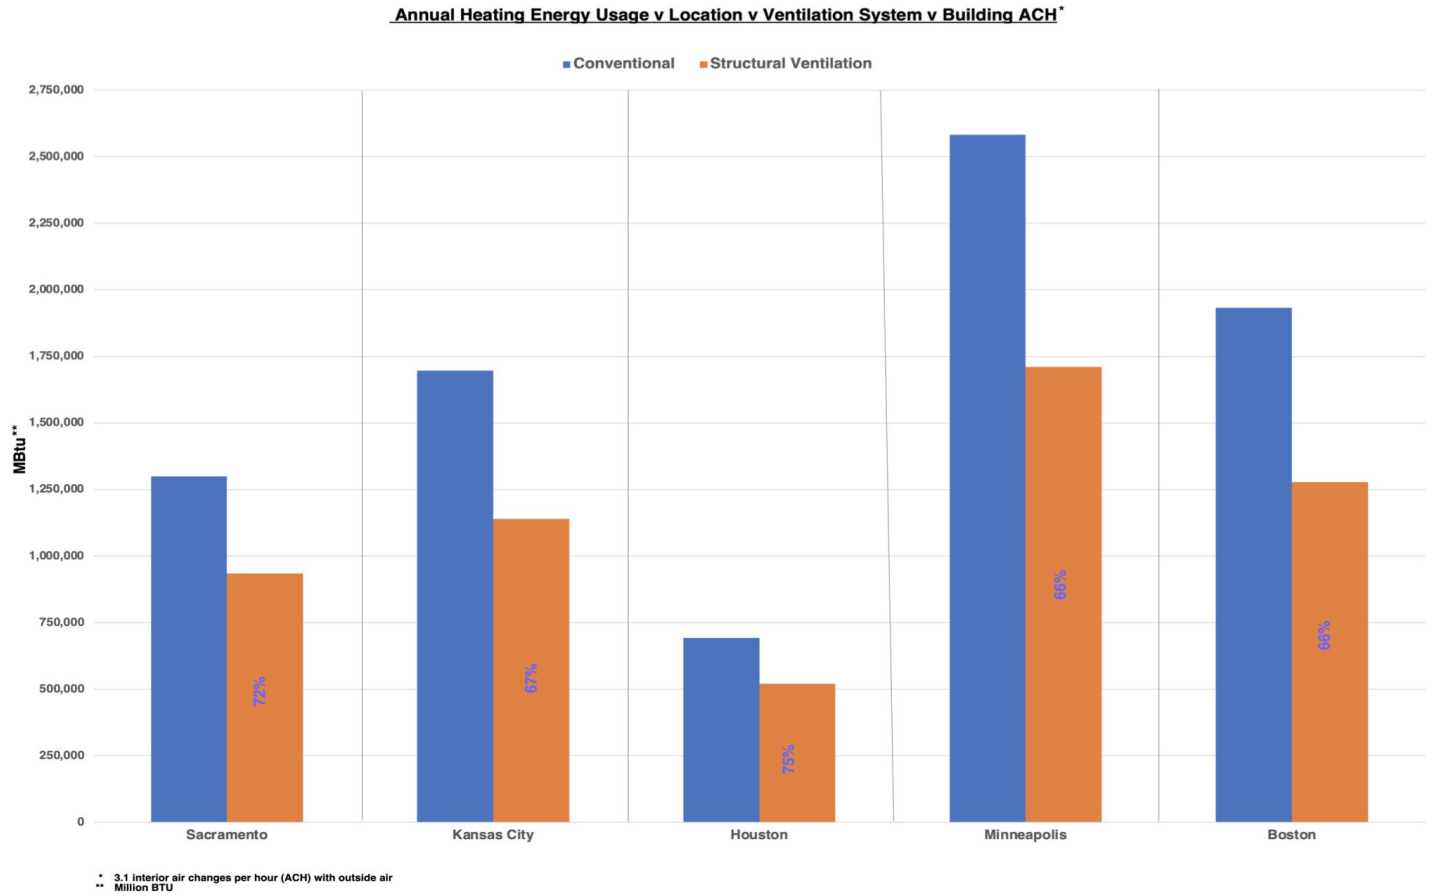
Figure 19 provides the annual heating energy usage of the school building at several cities. The conventional heating and SV heating requirements are presented as separate columns. The SV columns show percentages in the bars that indicates the percent SV energy usage is of conventional usage. **The percentages range from 66% to 75%.**

Figure 19 - School Heating Energy Usage v City v Ventilation System

SV results in significant energy savings regardless of location.

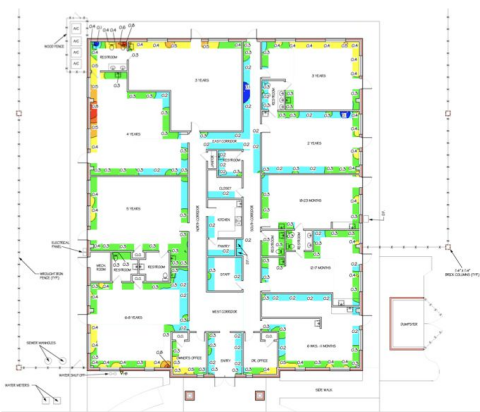
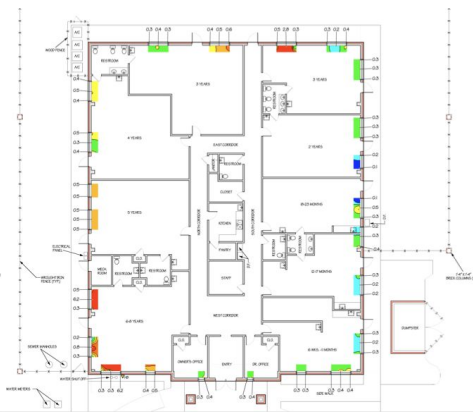
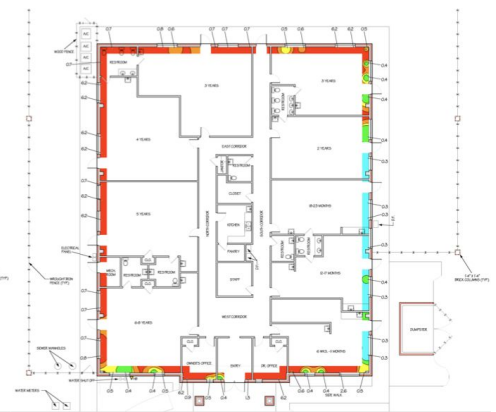
Figures 20.1 through 20.3 represent moisture content readings at the walls of a one-story, one-year old, daycare. Gypsum sheathing was measured at the exterior faces of the wall studs and gypsum board was measured at the interior of the structure. The interior gypsum board finish moisture contents are elevated at the perimeter of the building. Window leaks are evident. The gypsum sheathing behind the brick veneer is very wet.

Figure 20.1 - Daycare Gypsum Board Moisture Content Readings

Figure 20.2 - Daycare Windowsill Moisture Content Readings

Figure 20.3 - Daycare Gypsum Sheathing Moisture Content Readings

In this instance, the weep holes at the base of the wall were plugged with mortar, rainwater was seeping behind the veneer, and the windows leaked.

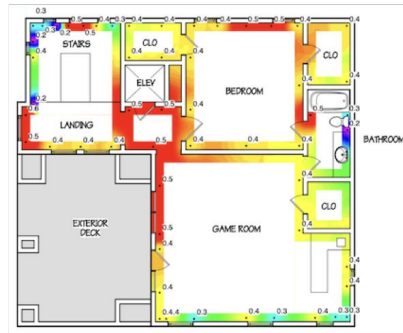
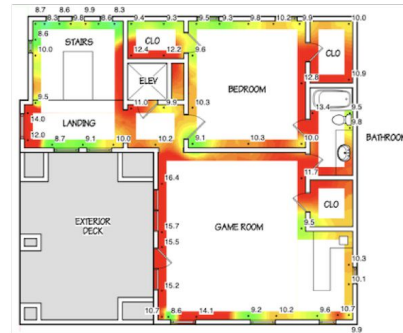
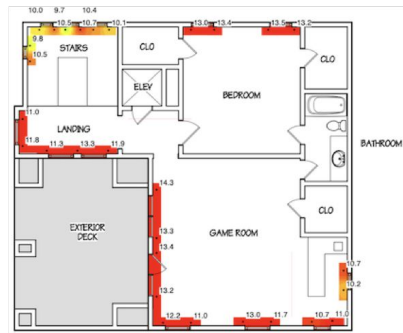
Figures 22.1 through 22.4 represent moisture content readings at the third floor walls and ceiling of a three-story, four-year old, house. Gypsum board, baseboards, windowsills, and the ceiling were measured at the interior of the structure.

The interior gypsum board moisture contents are elevated at the central area of the house and some exterior walls. The baseboards are more moist at the interior of the building as opposed to the perimeter. Windowsill readings are elevated. The ceiling is typically moist with greater moisture at the right side of the drawing.

Figure 22.1 - House Gypsum Board Moisture Content Readings

Figure 22.2 - House Baseboard Moisture Content Readings

Figure 22.3 - House Door and Windowsill Moisture Content Readings

Figure 22.4 - House Ceiling Moisture Content Readings

Moisture is collecting within the attic due to the lack of adequate ventilation. Moisture from this source is infiltrating the interior and perimeter walls of the upper floor. Window and door leakage are also issues.

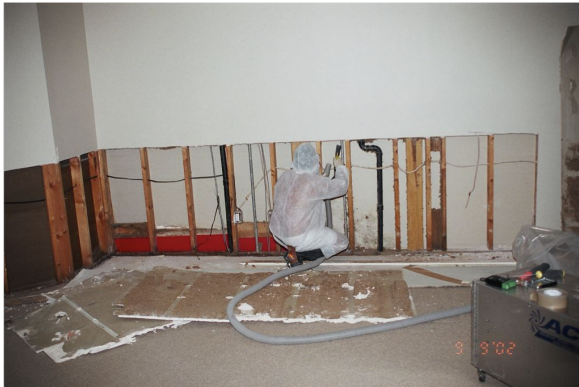
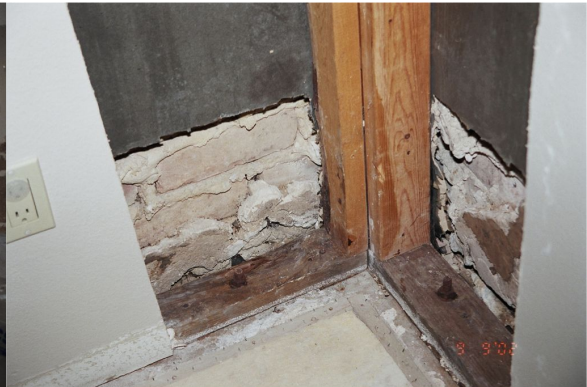
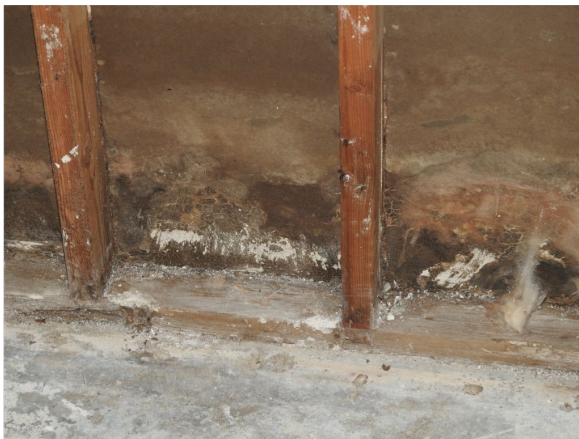
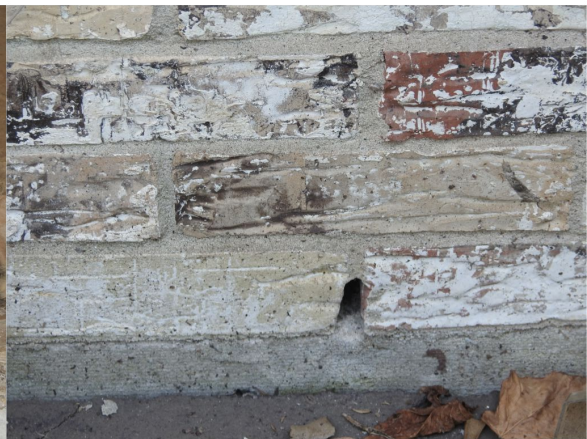
Plugged weep holes is the most common defect. See Figures 23.1 through 23.4. This occurs in at least 80% of structures investigated. From the exterior, the weep holes are visibly open; however, the air cavity is actually filled with mortar behind two or more brick courses. The resulting damages are exposing the exterior wall sheathing to excess moisture rendering it incapable of resisting Code specified lateral shear wall loads, rotting wood framing, and mold contamination.

Figure 23.1 - Mold decontamination

Figure 23.2 - Sheathing removed

Figure 23.3 - Sheathing moisture damage

Figure 23.4 - Plugged weep hole

These conditions would not exist with SV since the air passages would be required to be open to allow the system to function and moisture would be dried by continuous exhausted interior air.

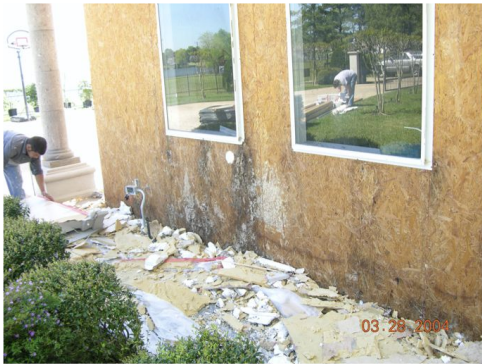
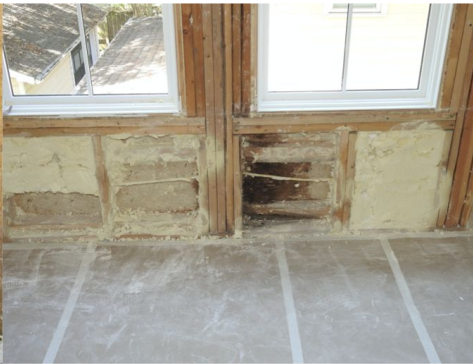
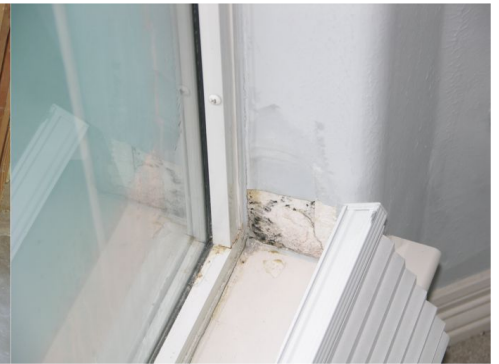
Window leakage is the second most common defect. See Figures 24.1 through 24.4. This occurs in at least 60% of structures investigated. The resulting damages are exposing the exterior wall sheathing to excess moisture rendering it incapable of resisting Code specified lateral shear-wall loads, rotting wood framing, and mold contamination.

This defect is typically due to improperly installed or absent flashing at the perimeter of the windows, lack of exterior sealants at the window perimeters, and/or misaligned or mis-fabricated windows frames.

Figure 24.1 - Sheathing moisture damage

Figure 24.2 - Sheathing moisture damage

Figure 24.3 - Mold at windowsill

With the SV system, these conditions would not exist since the windows would be located in front of the airstream and integral with the exterior finish. Moisture entering through the finish would be directed along the exterior edge of the airstream, dried by continuous exhausted interior air, and allowed to drain at the base of the wall.

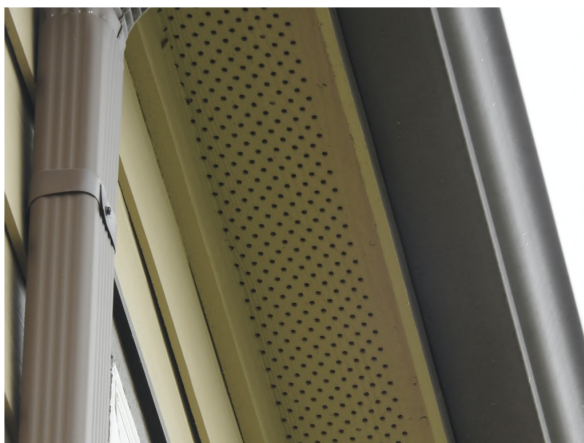
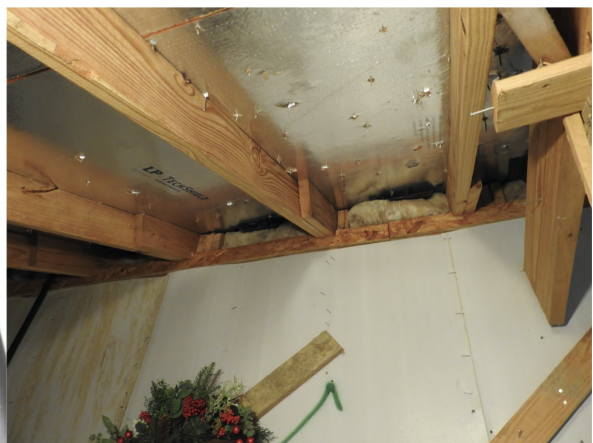
Restricted attic ventilation is the most probable cause of mold growth within attics. See Figures 25.1 and 25.2. Required by the building codes, attics are to be ventilated with raw outdoor air, typically provided with soffit and ridge vents. If not ventilated, moisture collects within the attic.

In many structures, the soffit vents are restricted due to insulation covering the vents with rafter vents compressed or absent. This easily results in mold growth. Inadequate ceiling insulation at the attic floor exacerbates the condition.

Figure 25.1 - Soffit vents

Figure 25.2 - Compressed rafter vents

With SV, these issues would not occur. Outside air is terminated and the attic is conditioned with exhausted indoor air. Proper ventilation is achieved.

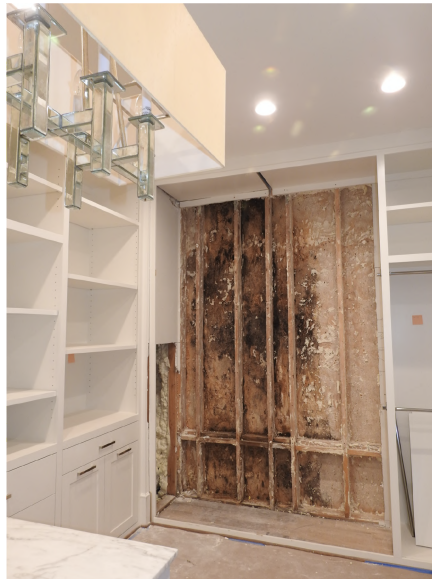
Roof leakage can go undetected. See Figure 26.1. In this instance, a scupper leaked behind the exterior stucco finish. The wall was constructed with the stucco applied directly to the exterior sheathing; an air cavity did not separate the exterior finish from the structural framing.

Figure 26.1 - Scupper leakage damage

With the SV system, these conditions would likely not exist since moisture entering through the finish would be directed along the exterior edge of the airstream and dried by continuous indoor air ventilation.

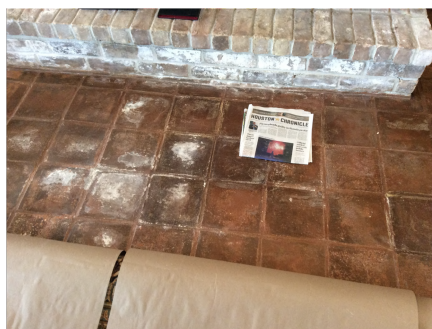
This is a common problem with vapor barriers more than 30 years of age. The polyethylene sheets lose their elasticity and become brittle. See Figure 26.2. Disturbed vapor barriers due to foundation or plumbing repairs are common.

Figure 26.2 - Moisture from damaged vapor barrier

With the SV system, moisture and contamination released into the air from the defect would be minimized.

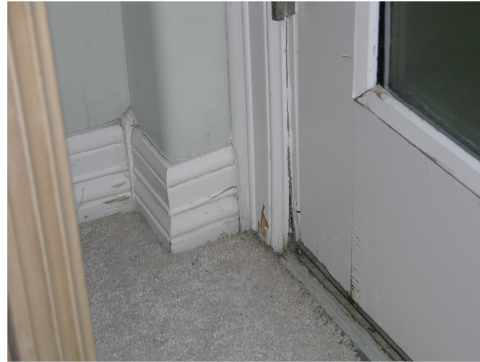
Door leakage is similar to window leakage. See Figure 27.1. This defect is typically due to improperly installed or absent flashing at the perimeter of the door frame, lack of exterior sealants at the door frame perimeters, and defective thresholds.

Figure 27.1 - Door leakage

With the SV system, these conditions would be minimized by the drying affect of the wall cavity and interior environment.

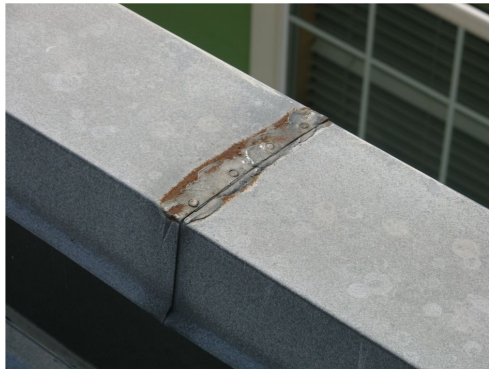
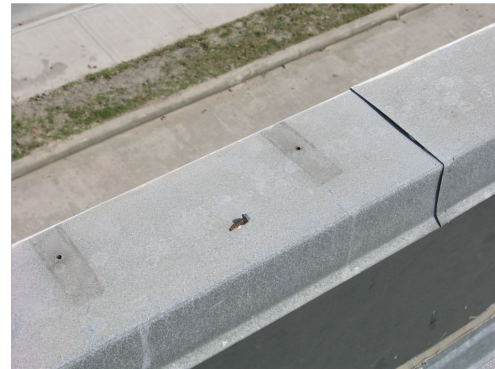
Cap flashing is the cap on the top of parapets. Defects are typically related to open joints and unsealed penetrations. Water enters the parapet and results in deterioration and mold growth. See Figures 27.2 and 27.3.

Figure 27.2 - Cap flashing separations

Figure 27.3 - Cap flashing openings

With the SV system, these conditions would be minimized by the drying affect of the airstream within the wall.
